DESIGNATED SUBSTANCES SURVEY

REASSESSMENT 2012

**St. Agnes School
Chatham, Ontario**

Project No.: 12-5738

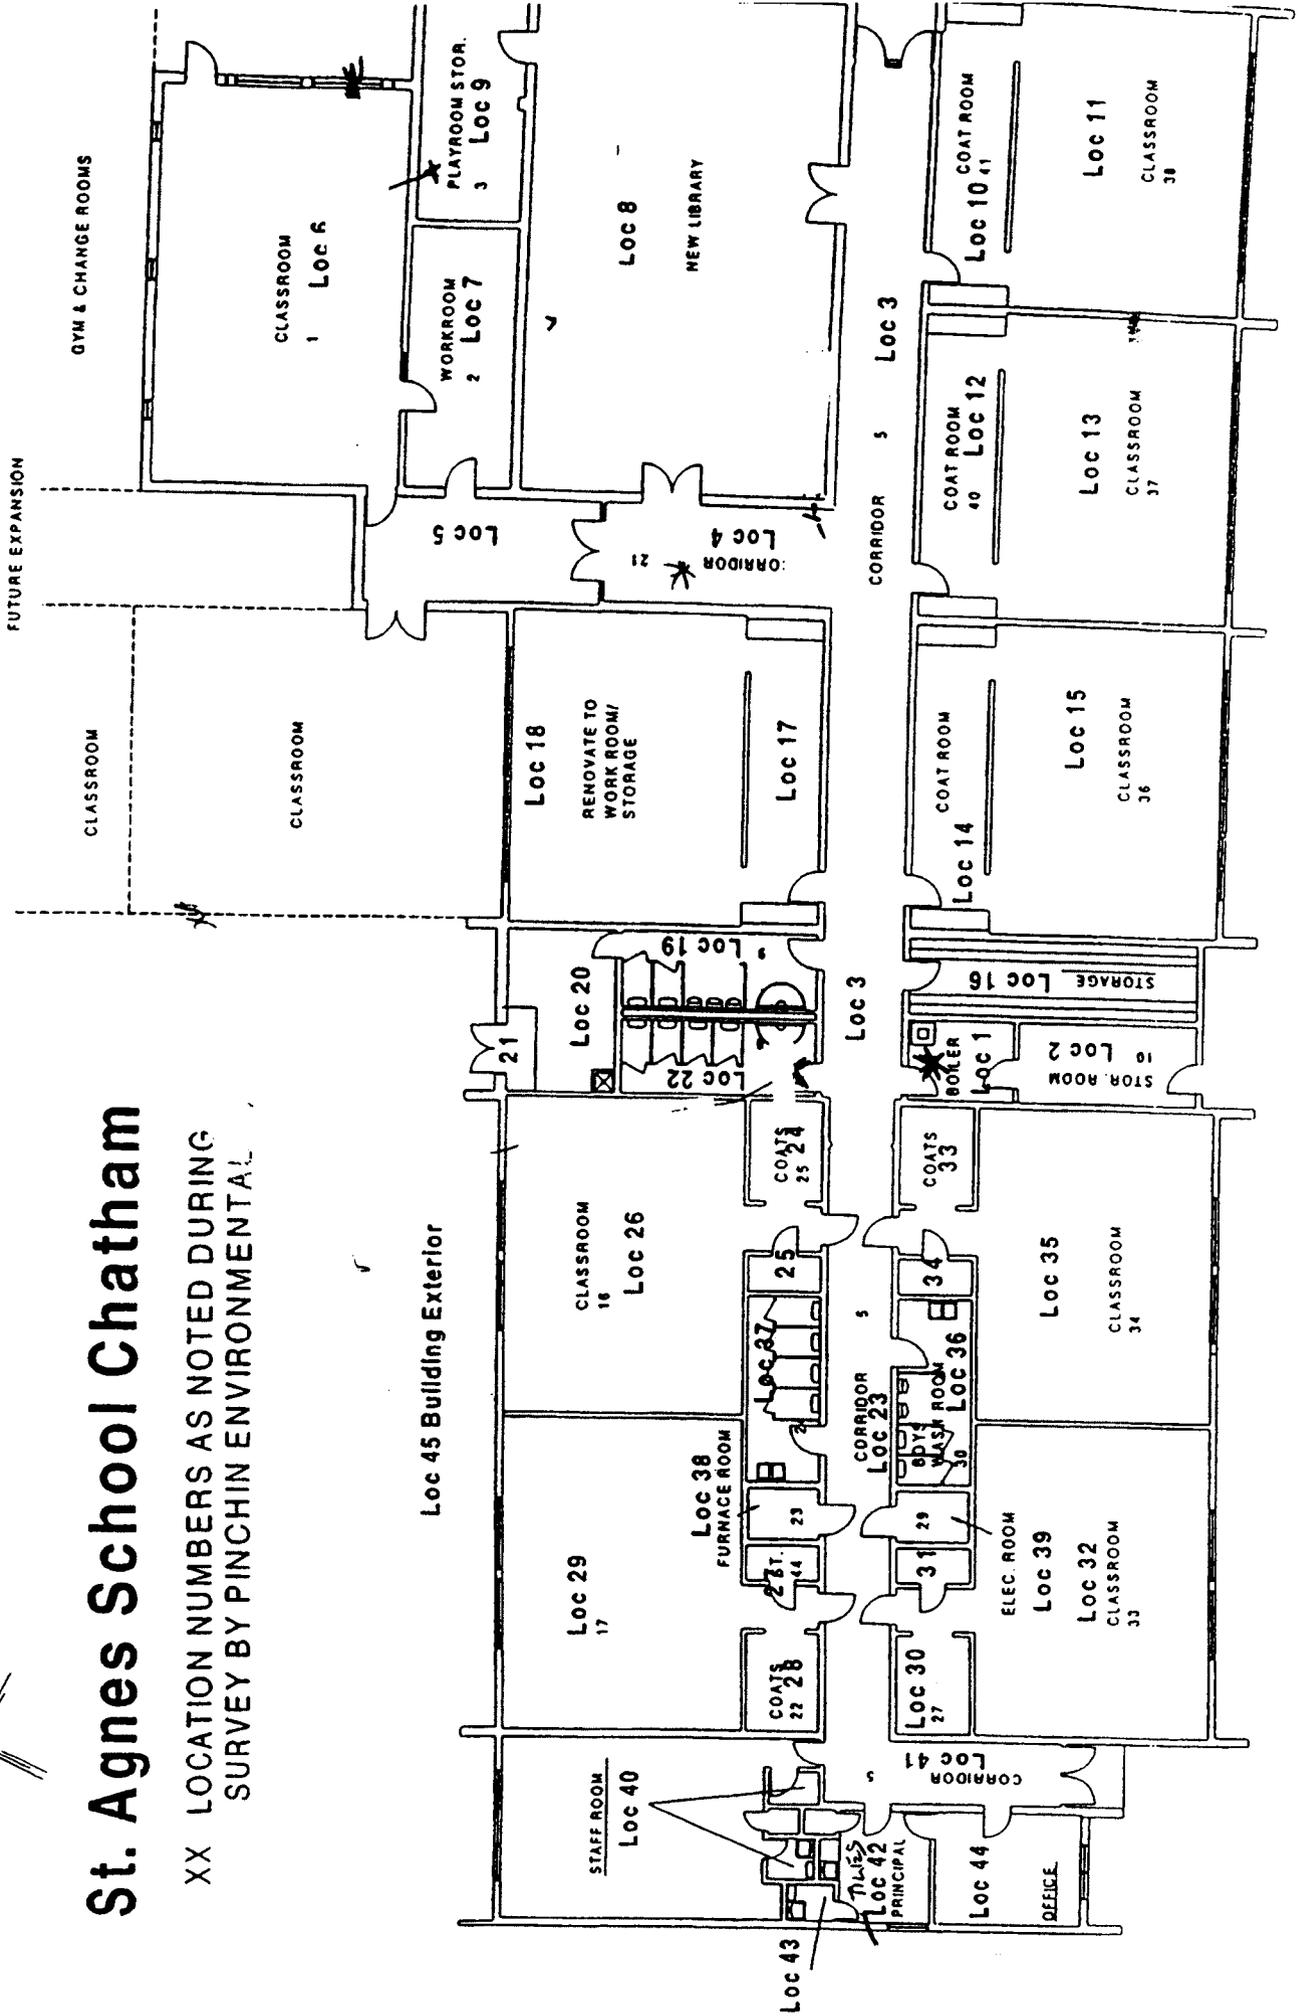
St. Agnes School Chatham

XX LOCATION NUMBERS AS NOTED DURING SURVEY BY PINCHIN ENVIRONMENTAL
