ADDENDUM

ME-01

Project: SCCDSB – St. Elizabeth School –
Boiler Replacement

Drawing Title:
 BOILER ROOM PIPING SCHEMATIC

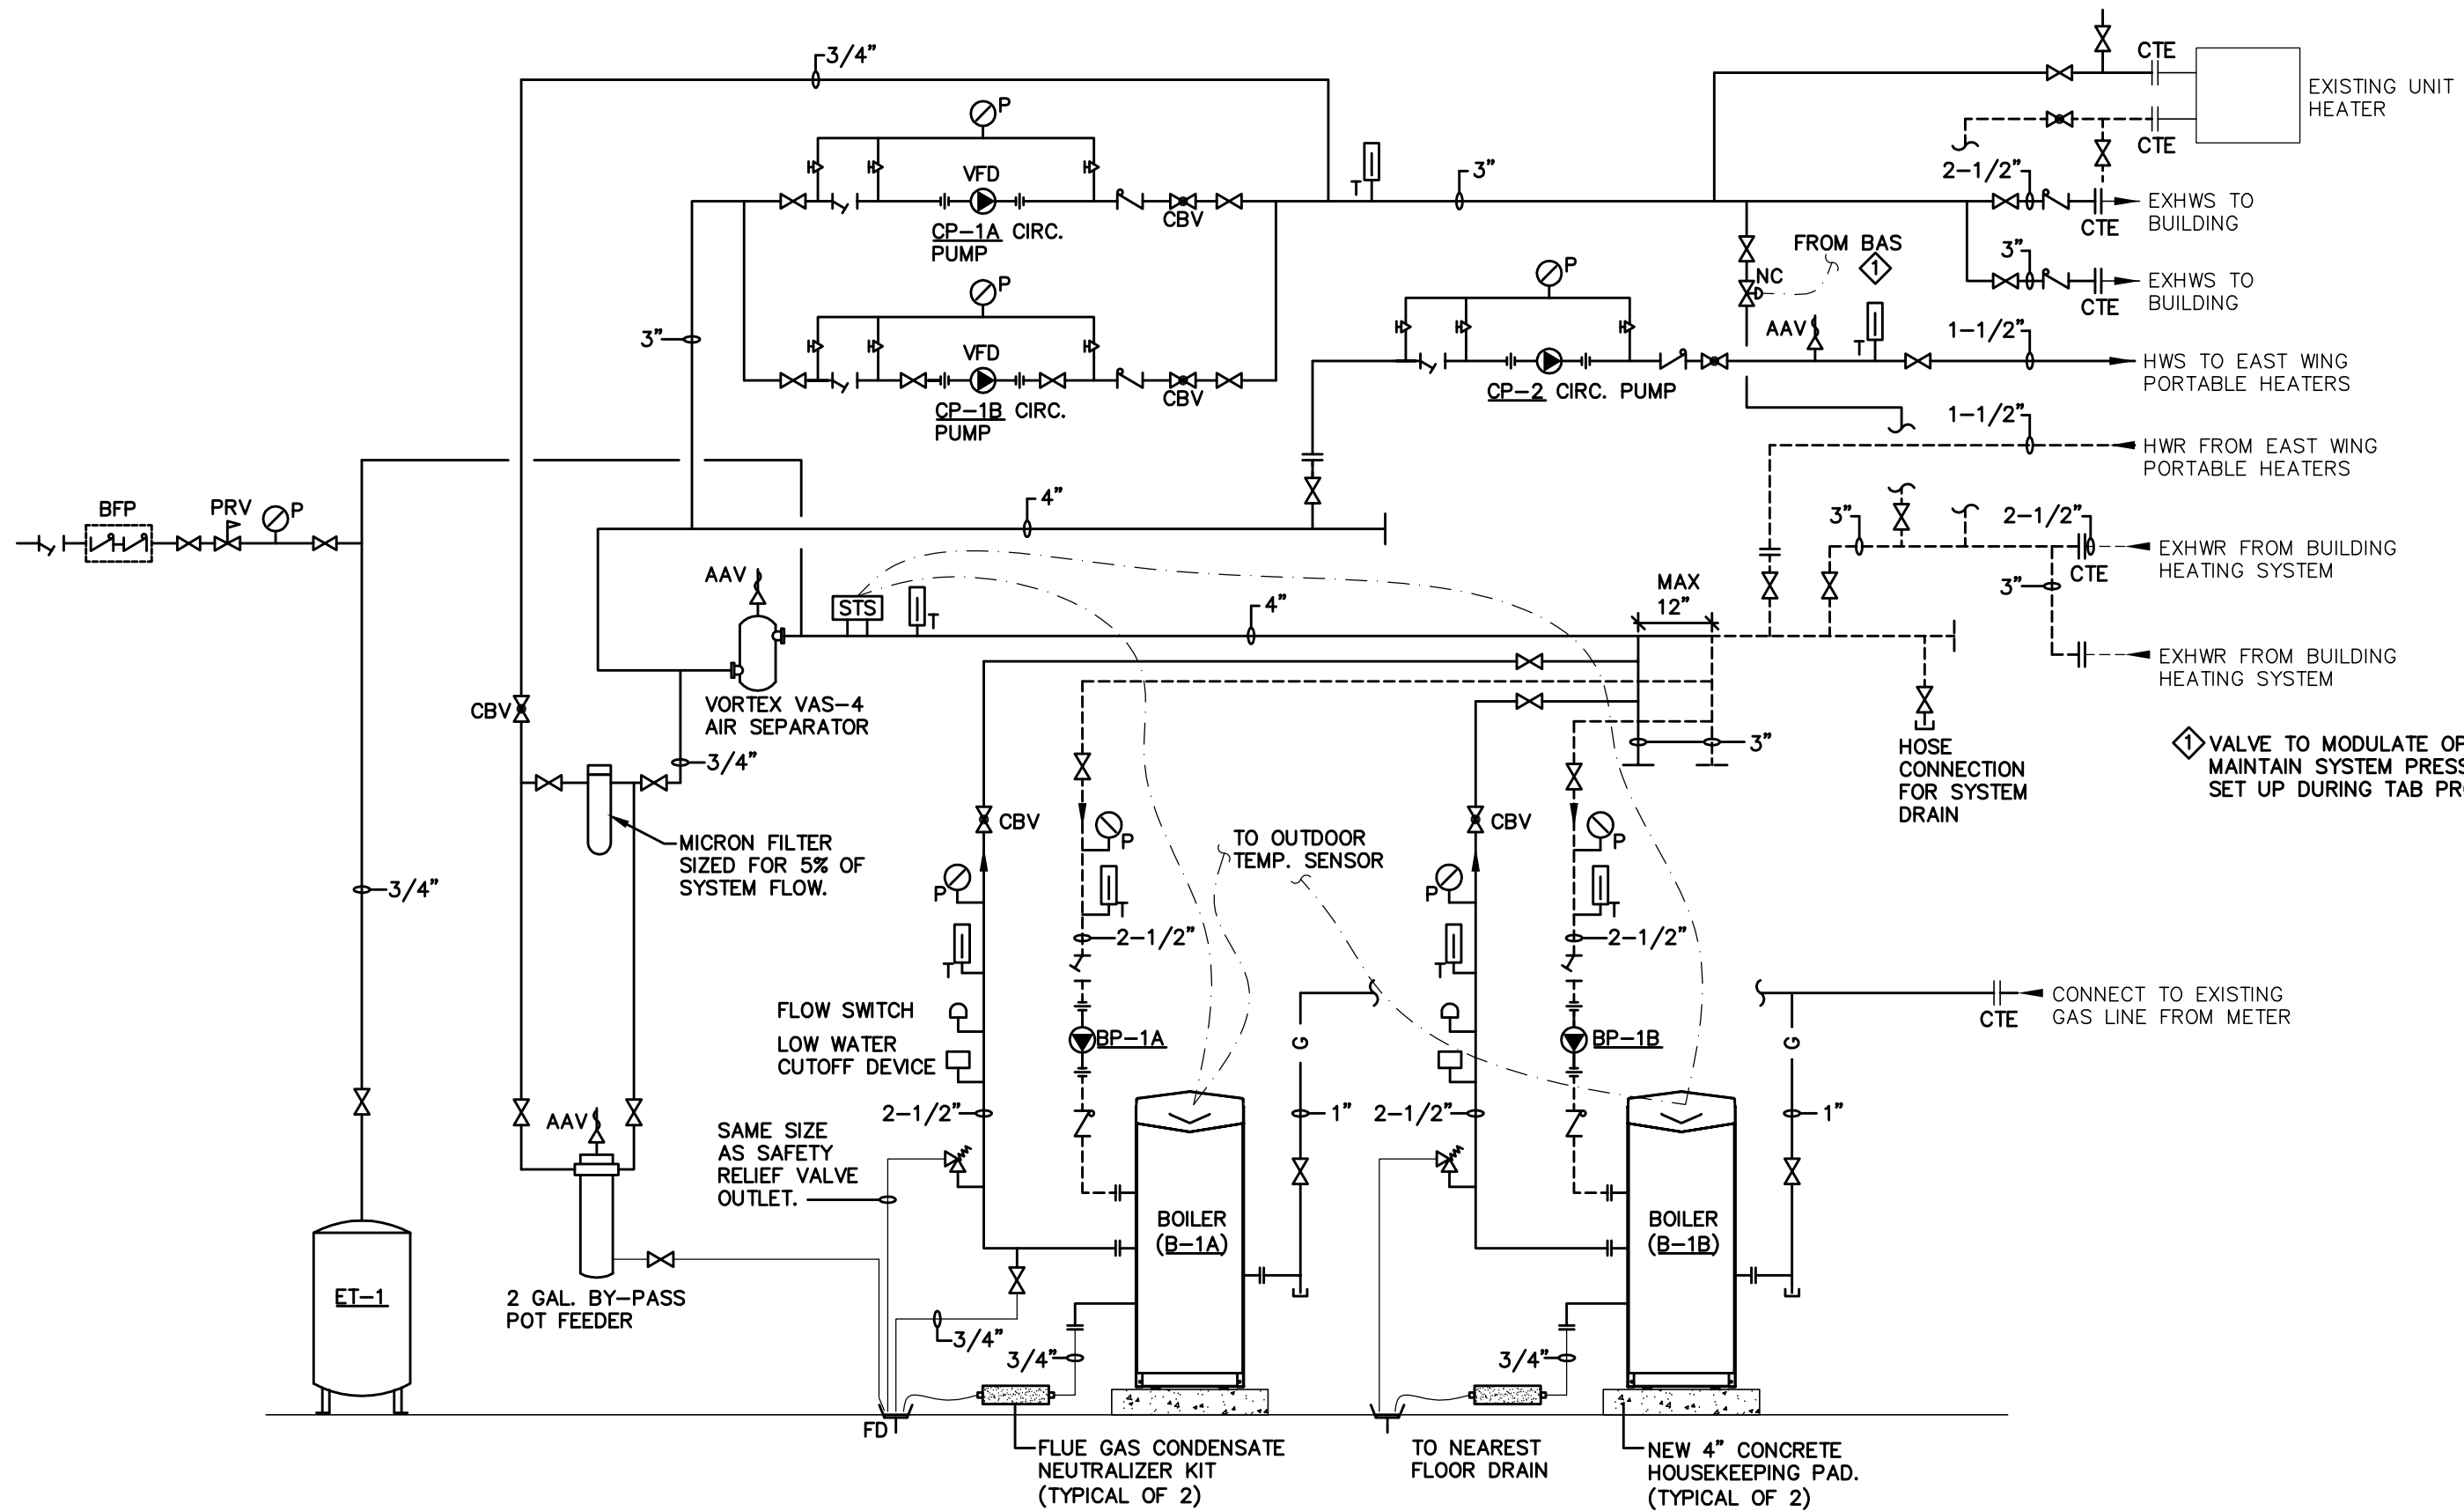
Ⓛ VALVE TO MODULATE OPEN TO MAINTAIN SYSTEM PRESSURE AS SET UP DURING TAB PROCESS.

.1 Refer to attached sketch M-5R, Boiler room piping schematic; and replace the drawing M-5 with M-5R in its entirety.
