DESIGNATED SUBSTANCES SURVEY

REASSESSMENT 2012

**St. Elizabeth School
Wallaceburg, Ontario**

Project No.: 12-5738

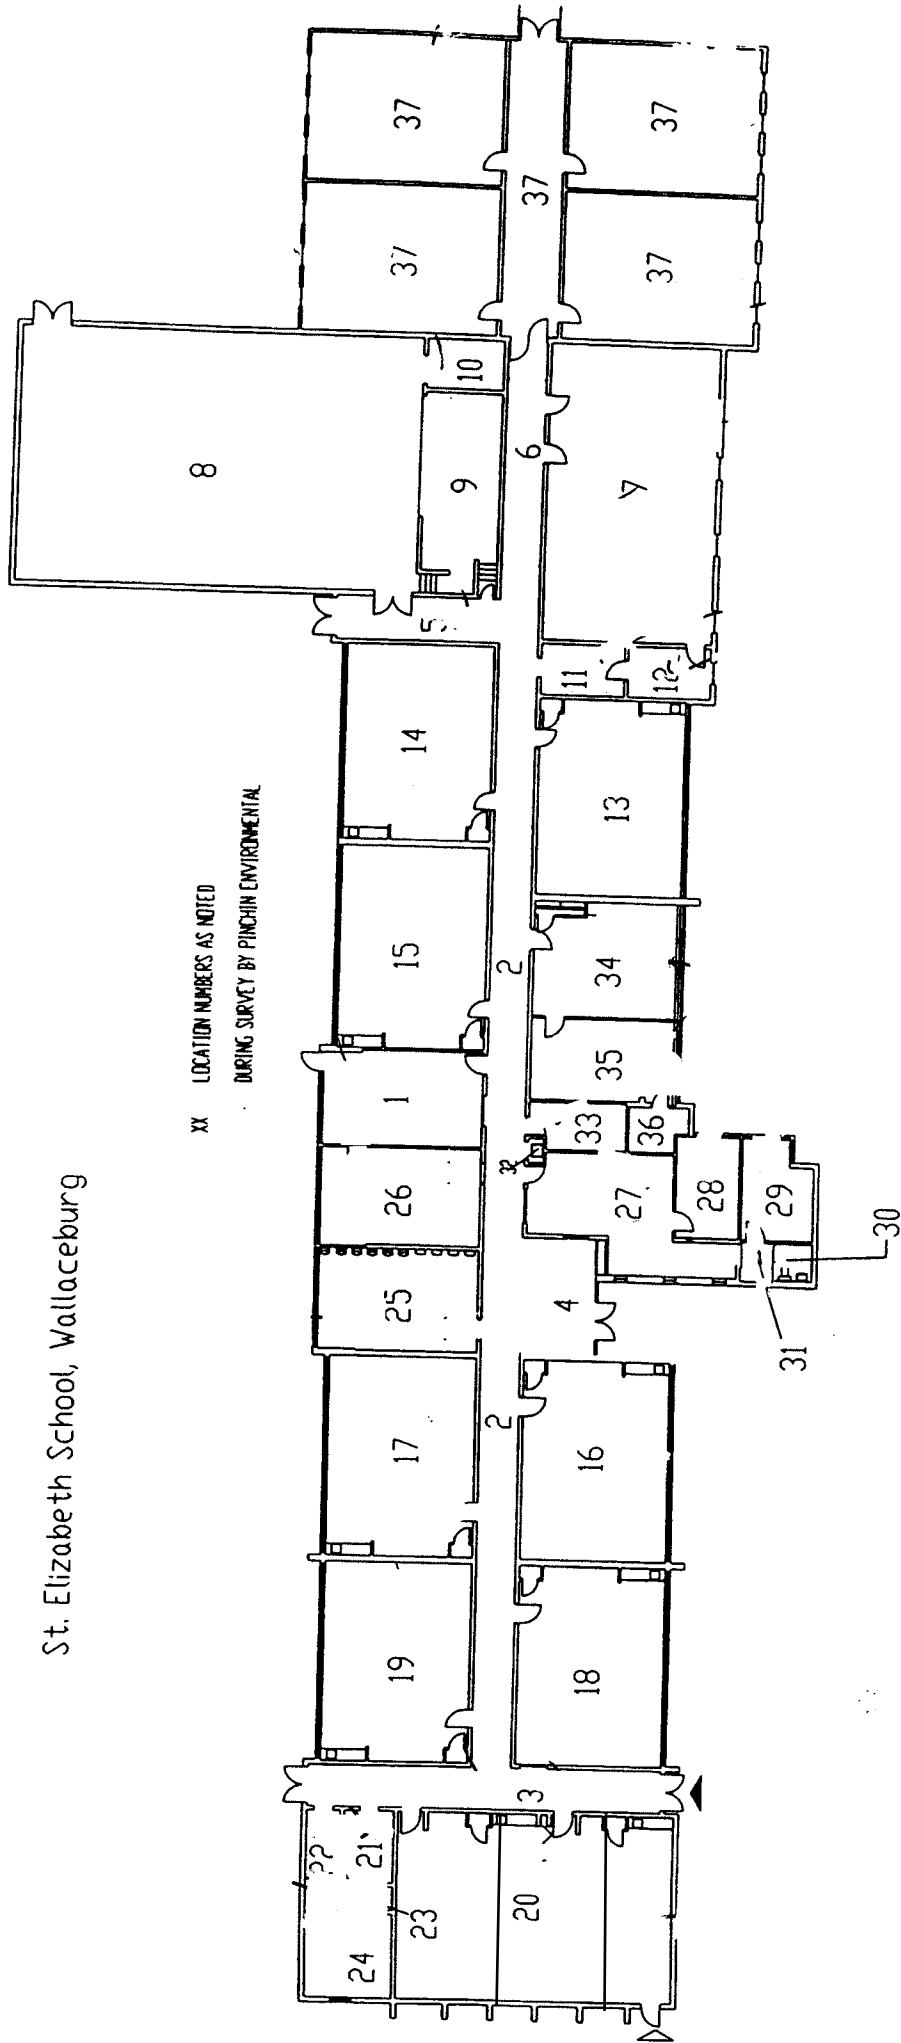
St. Elizabeth School, Wallaceburg

XX LOCATION NUMBERS AS NOTED
DURING SURVEY BY PINCHIN ENVIRONMENTAL
